UNIVERSITY OF CALIFORNIA
INSTITUTE OF ENGINEERING RESEARCH
BERKELEY, CALIFORNIA

SURVEYS OF FALLOUT SHELTER -- A COMPARISON
BETWEEN AERIAL PHOTOGRAPHIC AND DOCUMENTARY METHODS

By
D. C. Kleinecke

DATE February 1, 1960

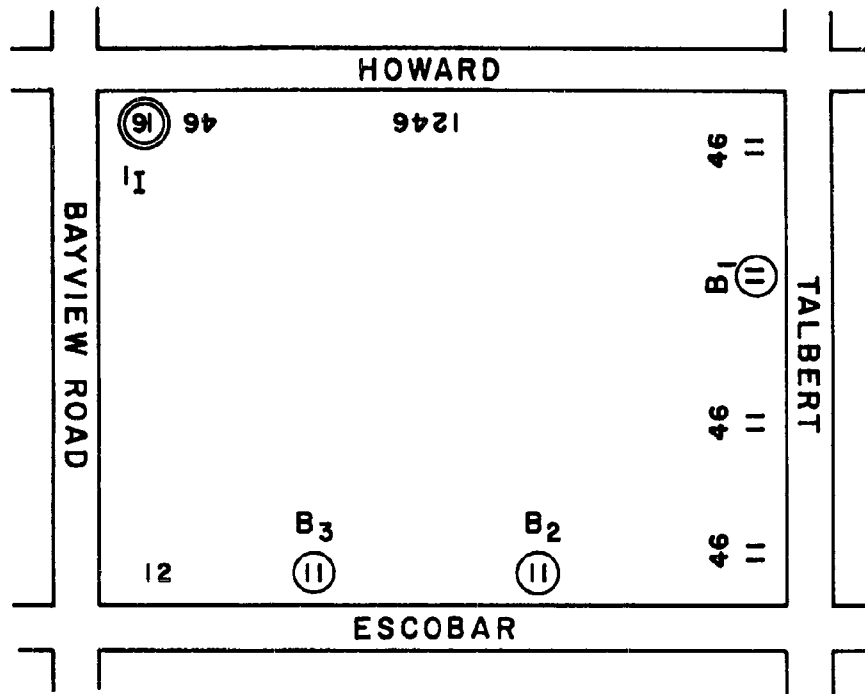
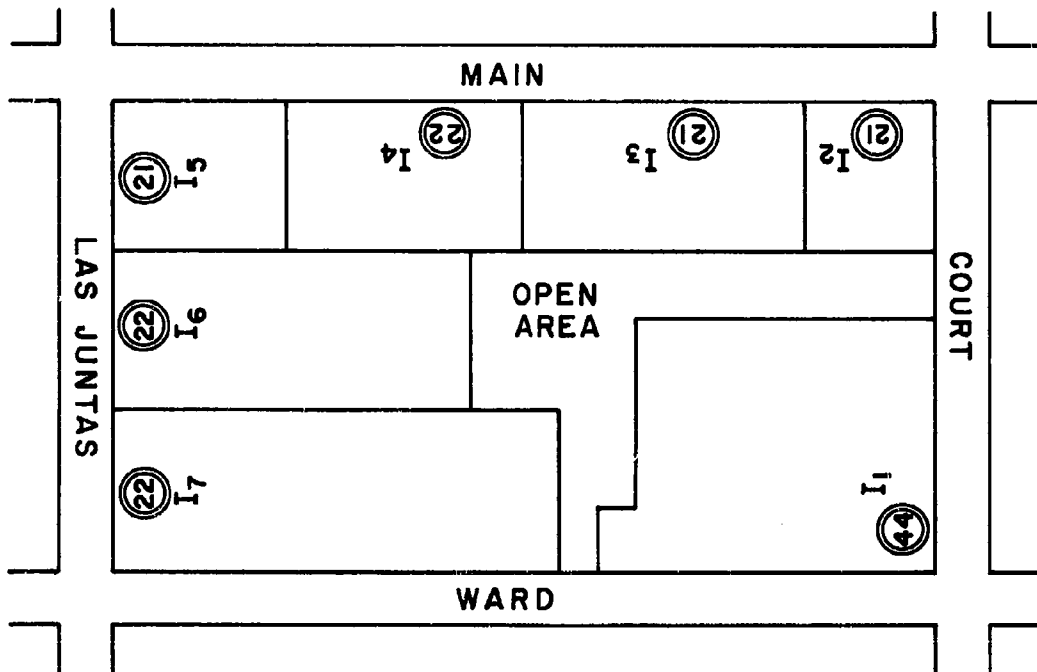
FIGURE 1
TYPICAL BLOCK RECORDS

The photo-interpreters divided the survey area into 379 smaller areas, usually a city block, which were each individually reported on 5 x 8 cards. On each card there is an outline map of the area reported; and a code figure for each structure observed is given in the approximate position of the structure. The code used is given as an appendix. In the downtown area, structural shapes were reproduced. Figure 1 illustrates the appearance of two typical blocks.

- RESIDENTIAL BLOCK -

- DOWNTOWN BLOCK -

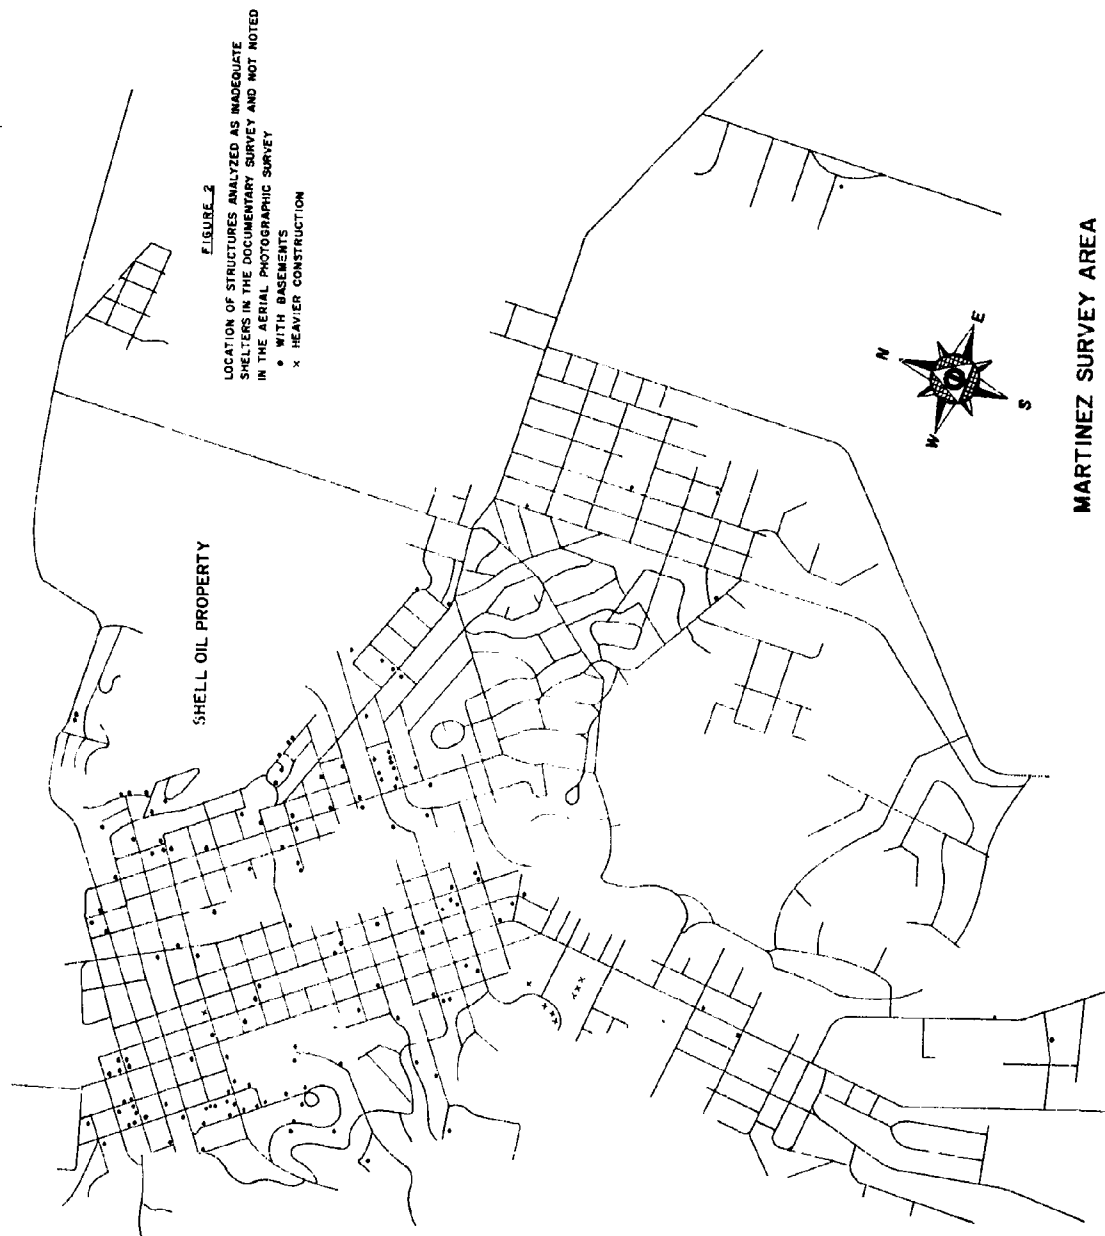
Figure 2 shows those structures which were analyzed by the documentary survey as inadequate in shelter effectiveness and not noted in the aerial photographic survey. Figure 3 shows those structures of this type which were noted in the aerial photographic survey as "B" structures. The problem of "B" structures is discussed in more detail below.

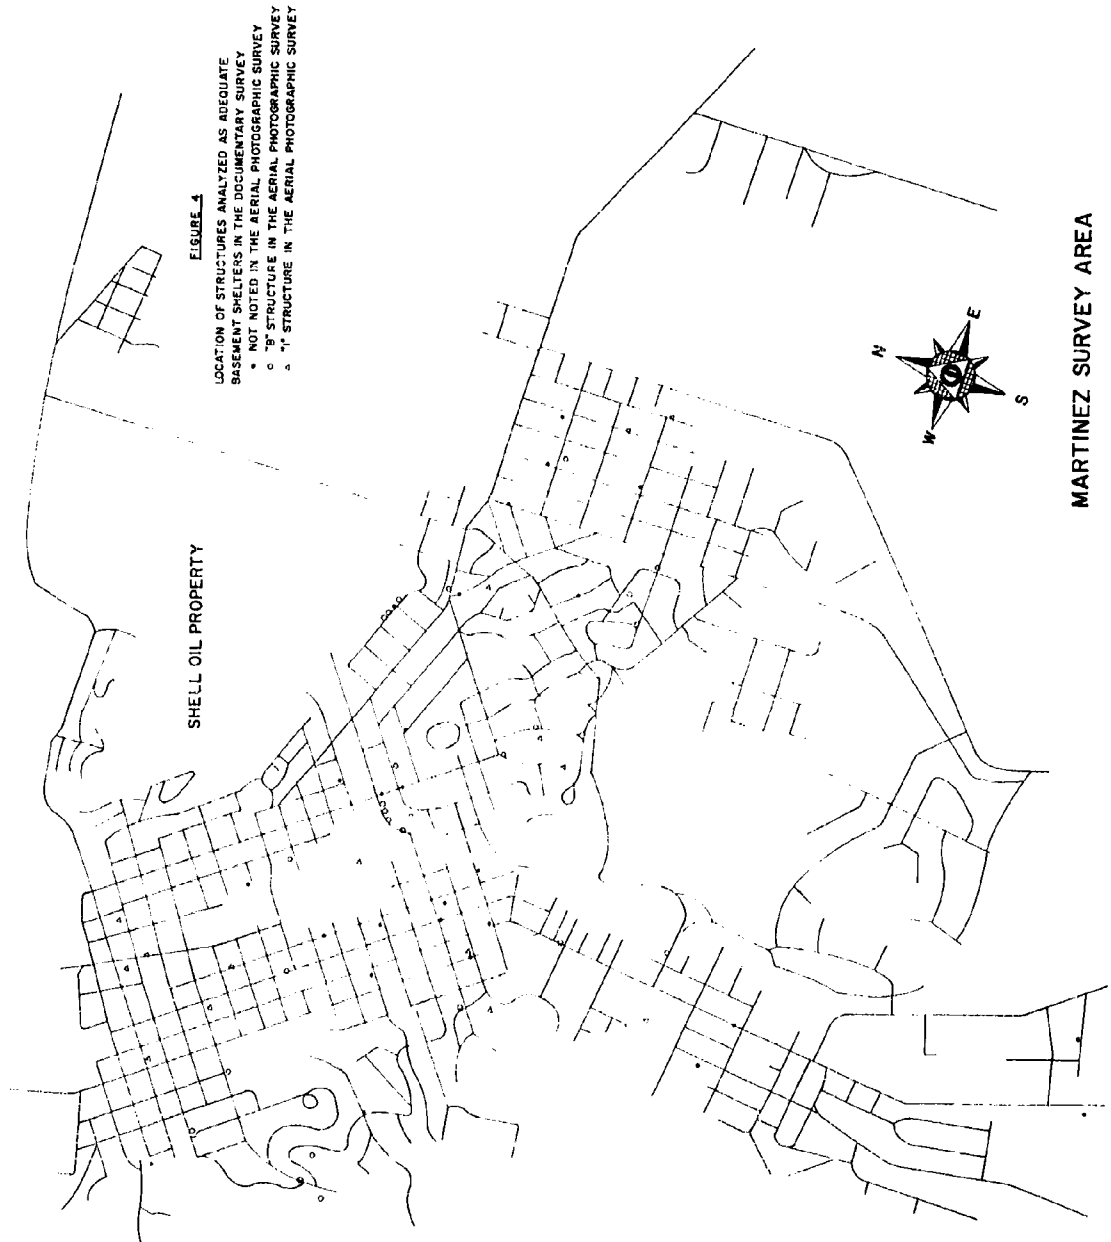
Figure 4 shows the structures with basements analyzed in the documentary survey as adequate shelters. There are three subgroupings depending on whether they were not noted, noted as "B", or noted as "I", in the aerial photographic survey.

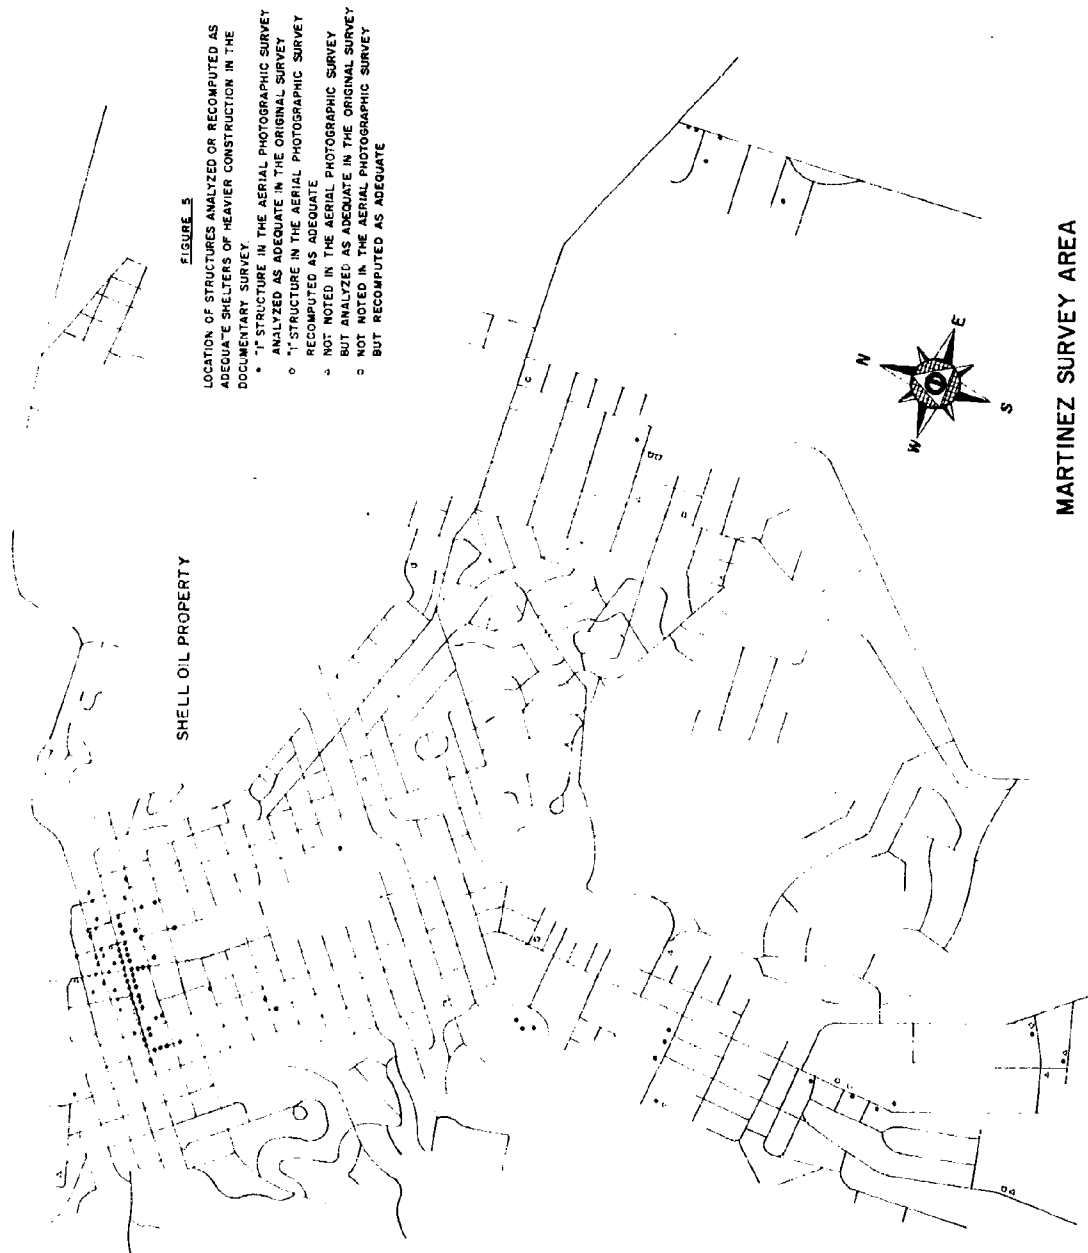
Figure 5 shows the heavier structures analyzed in the documentary survey as adequate, or recomputed as adequate. There are four subgroupings depending on whether or not they were noted as "I" in the aerial photographic survey, and whether they were analyzed in the original survey as adequate or recomputed as adequate. None of these structures were noted as "B" in the aerial photographic survey.

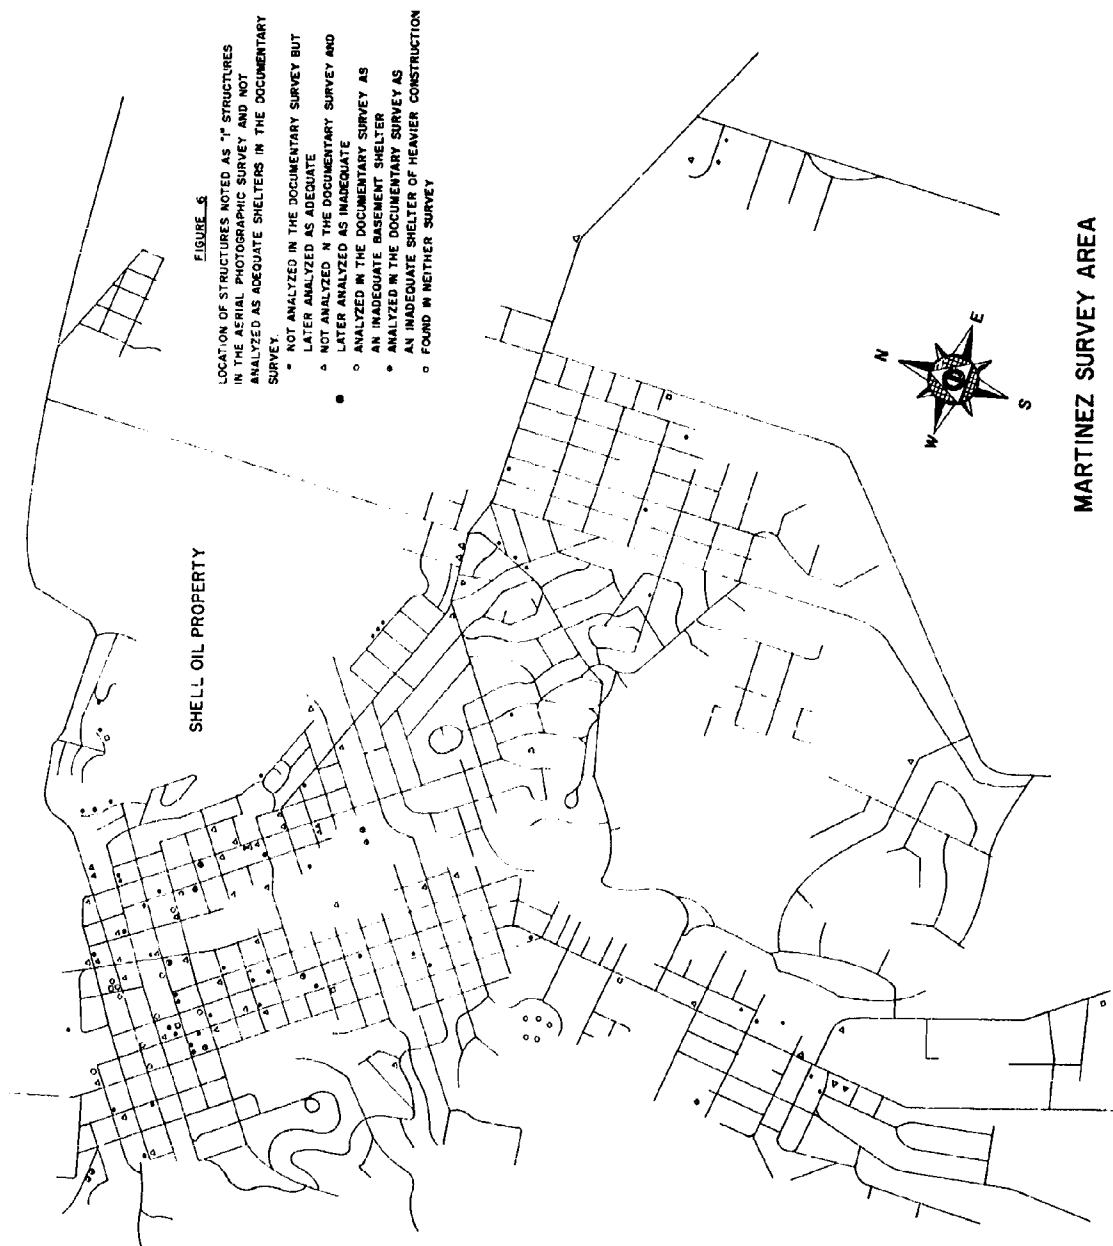
Figure 6 shows the structures noted in the aerial photographic survey as "I" structures (and the heavier structures missed by both surveys). There are four subgroupings of "I" structures -- one of structures analyzed as adequate, and three of structures analyzed as inadequate.

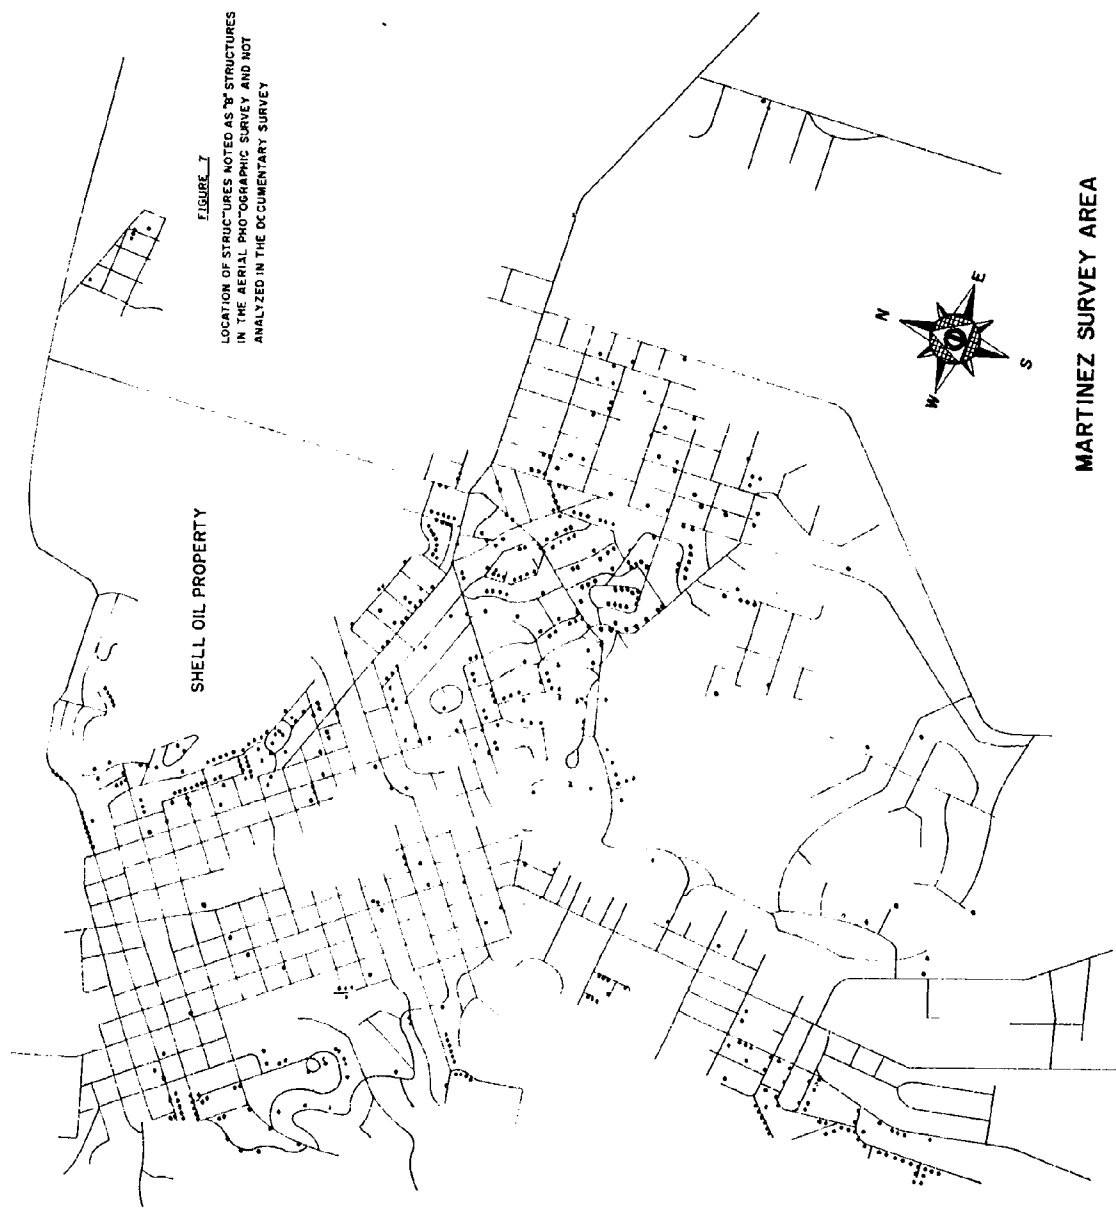
FIGURE 1
LOCATION OF STRUCTURES NOTED AS "X" STRUCTURES
IN THE AERIAL PHOTOGRAPHIC SURVEY AND NOT
ANALYZED IN THE DOCUMENTARY SURVEY

Figure 7 shows the "B" structures not analyzed in the documentary survey.
